RESOURCE CONSERVATION AND RECOVERY ACT FACILITY ASSESSMENT REPORT
NAS KEY WEST FL
3/30/1989
U S EPA REGION IV

RCRA FACILITY ASSESSMENT REPORT

US NAVAL AIR STATION
BOCA CHICA KEY
KEY WEST, FLORIDA 33040

SUBJECT: Visual Site Inspection, RCRA Facility Assessment
U.S. Naval Air Station, Key West, Florida
EPA I.D. No. FL6 170 022 952

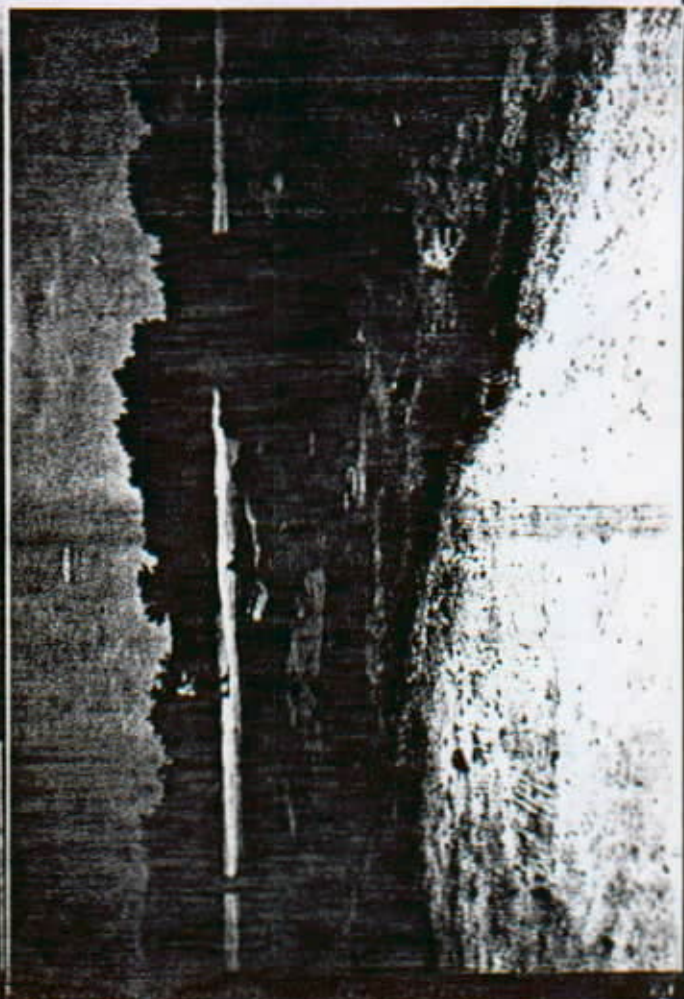
6 AIMD Building A980 Drum

In the past, two (2) plastic drums were buried in the ground just outside the electronic parts cleaning building. The drums were connected to pipes that were connected to floor drains inside of the building. These drums were in operation from 1981-1987. The drums are no longer connected to the inside drains (see photo 6). The waste in the floor drains is now collected in drums and taken to a temporary drum storage area.

The area directly surrounding the drum in photo #6 has been dug up to expose the entire drum. Stains have been noted around the drum area. At the time of the RFA, NAS indicated that some sampling was currently being done by a contractor.

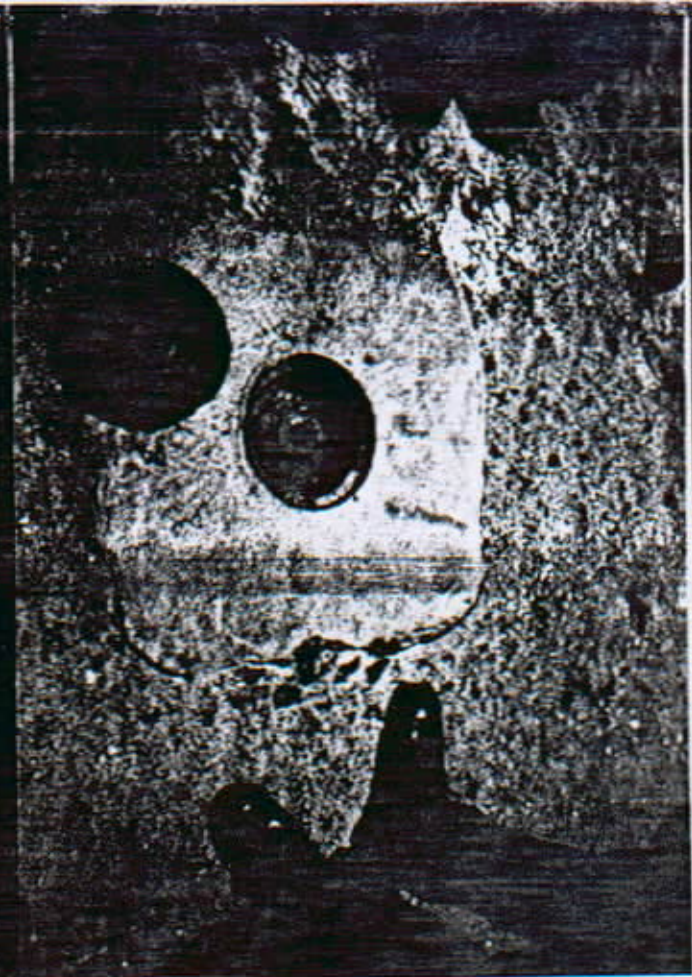
Two shallow monitoring wells are located at the site (KWM 18 and KWM 19) (see photos 9,10). The well caps are severely corroded and the well heads were below ground level and covered with water.

9 Northernmost well at Fire Fighting Area

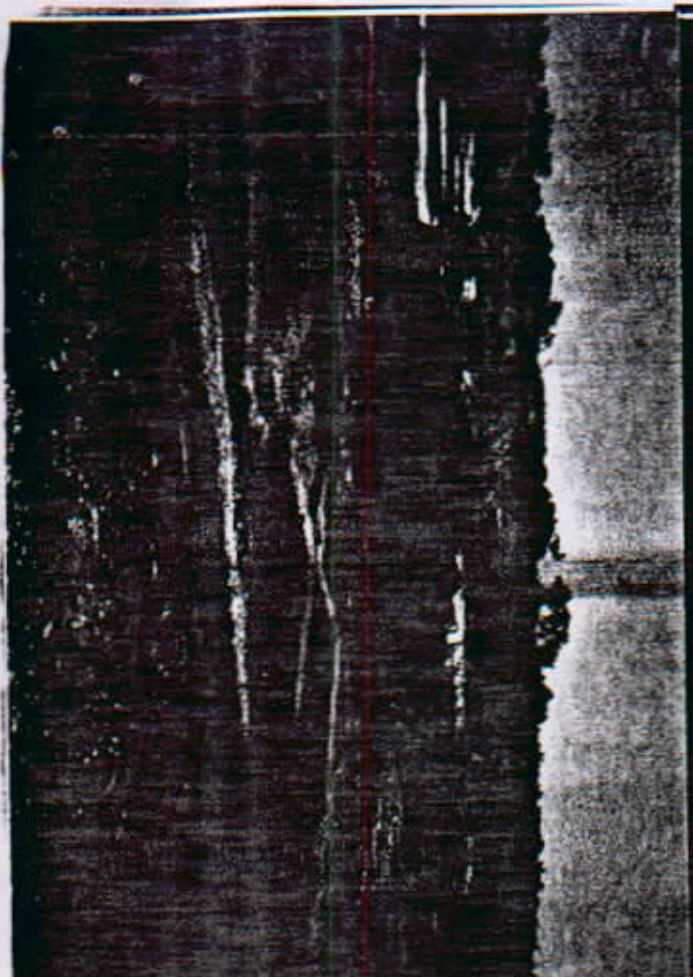
10 Southernmost well at Fire Fighting Area

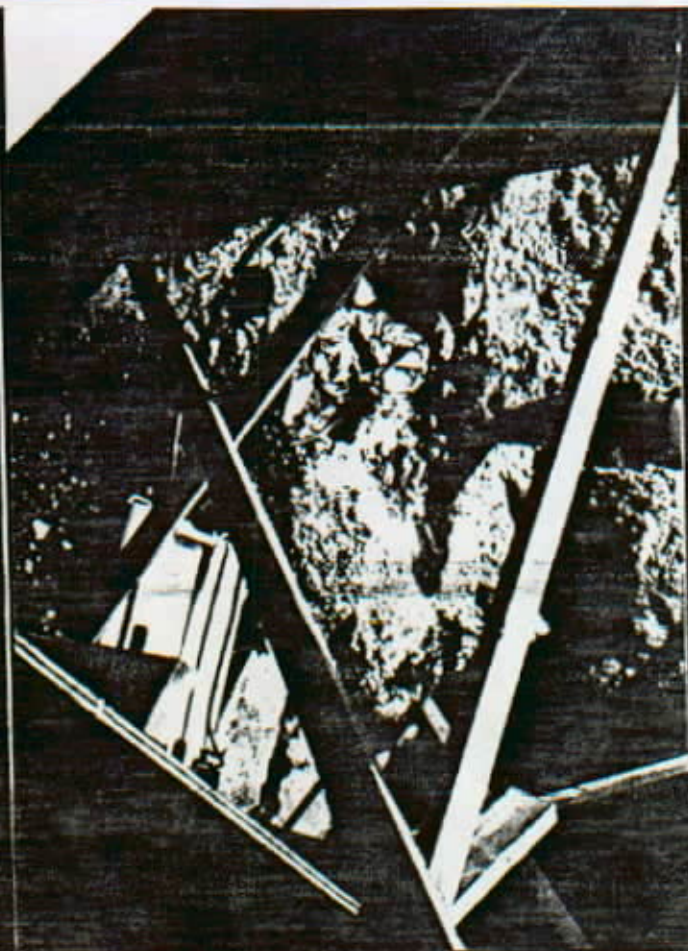
17 Old Drum Storage Area-Transformers

At the time of the RFA/VSI it was noted that the grounds adjacent to the old storage building may contain contamination caused from transformers stored on pallets on the ground outside. If this area is not addressed by the closure activities required by the closure permit it must be addressed as a SWMU under the HSWA permit. Thus it would be included in the RFI procedures.

Five (5) of the SWMUs included in the RFA should be included in the RFI work plan required by the final HSWA permit. Any contamination found adjacent to the Old Hazardous Waste Storage Unit at the Main RCRA Hazardous Waste Storage Area that is not addressed under closure of the unit must be addressed as release from a SWMU.
